Death in the line of duty...

A summary of a NIOSH fire fighter fatality investigation

November 9, 2009

Two Career Fire Fighters Die While Making Initial Attack on a Restaurant Fire –Massachusetts

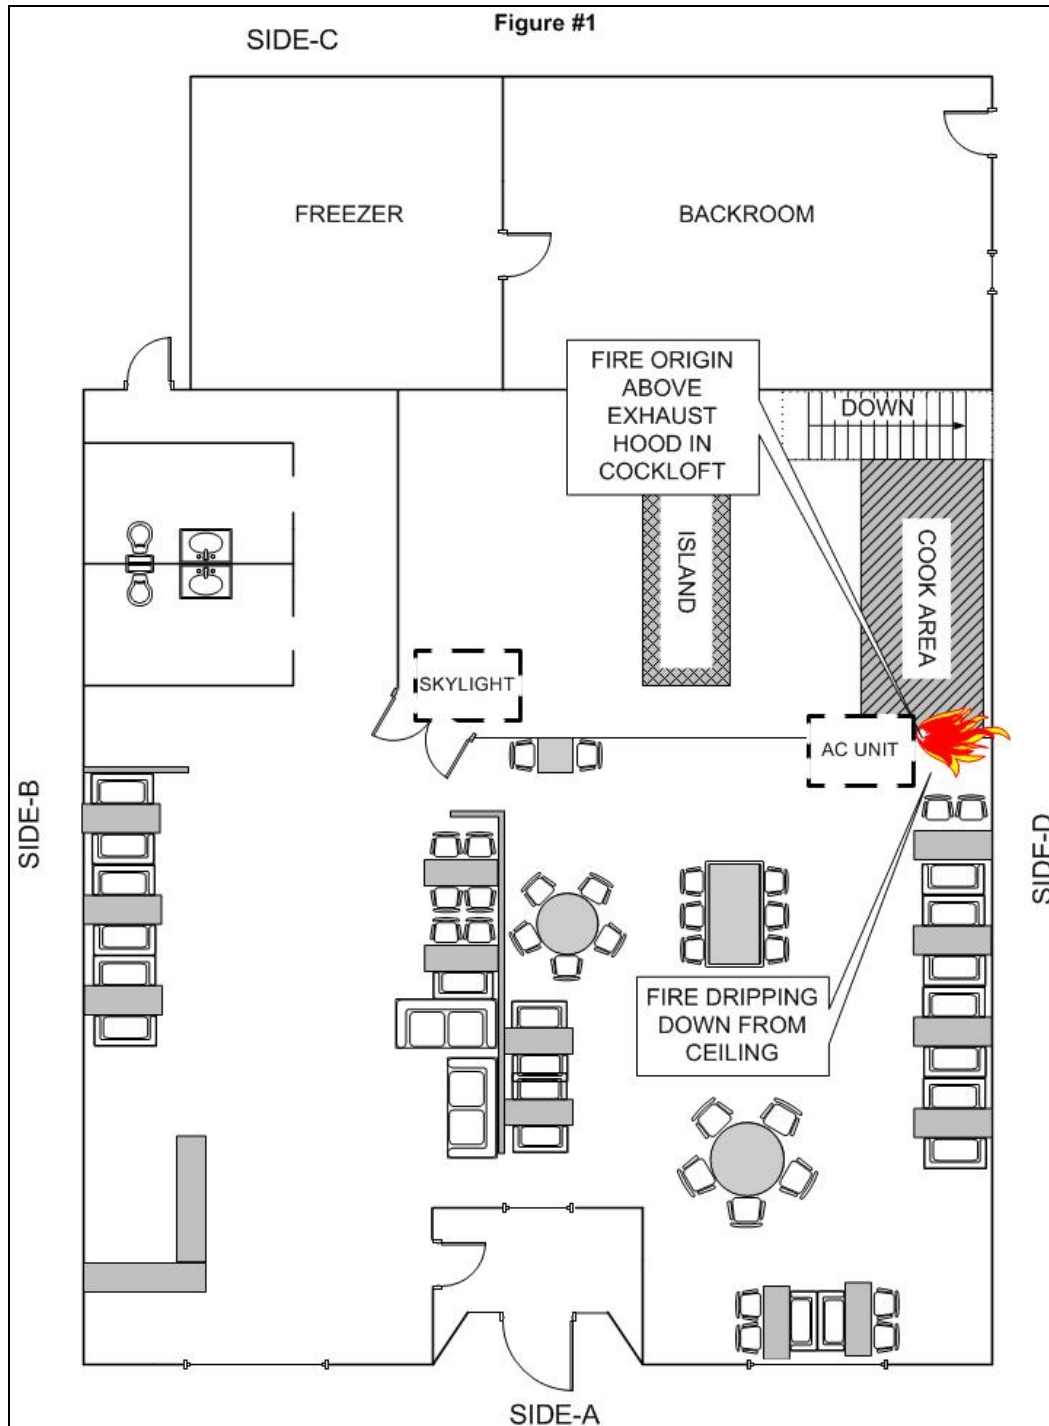
The roof was sloped towards the back and had a 3 ft parapet wall on the front. It consisted of built-up rubber roofing with backer board over the original tar and gravel roof. There was a 3-ton heating, venting, and air conditioning unit (HVAC) on the roof, that weighed approximately 400 pounds. There was also a skylight that measured 3 ft 8 in x 3 ft 5 in. Both were located over the kitchen area (Figure 1).

Figure 1. Layout of restaurant and fire origin.

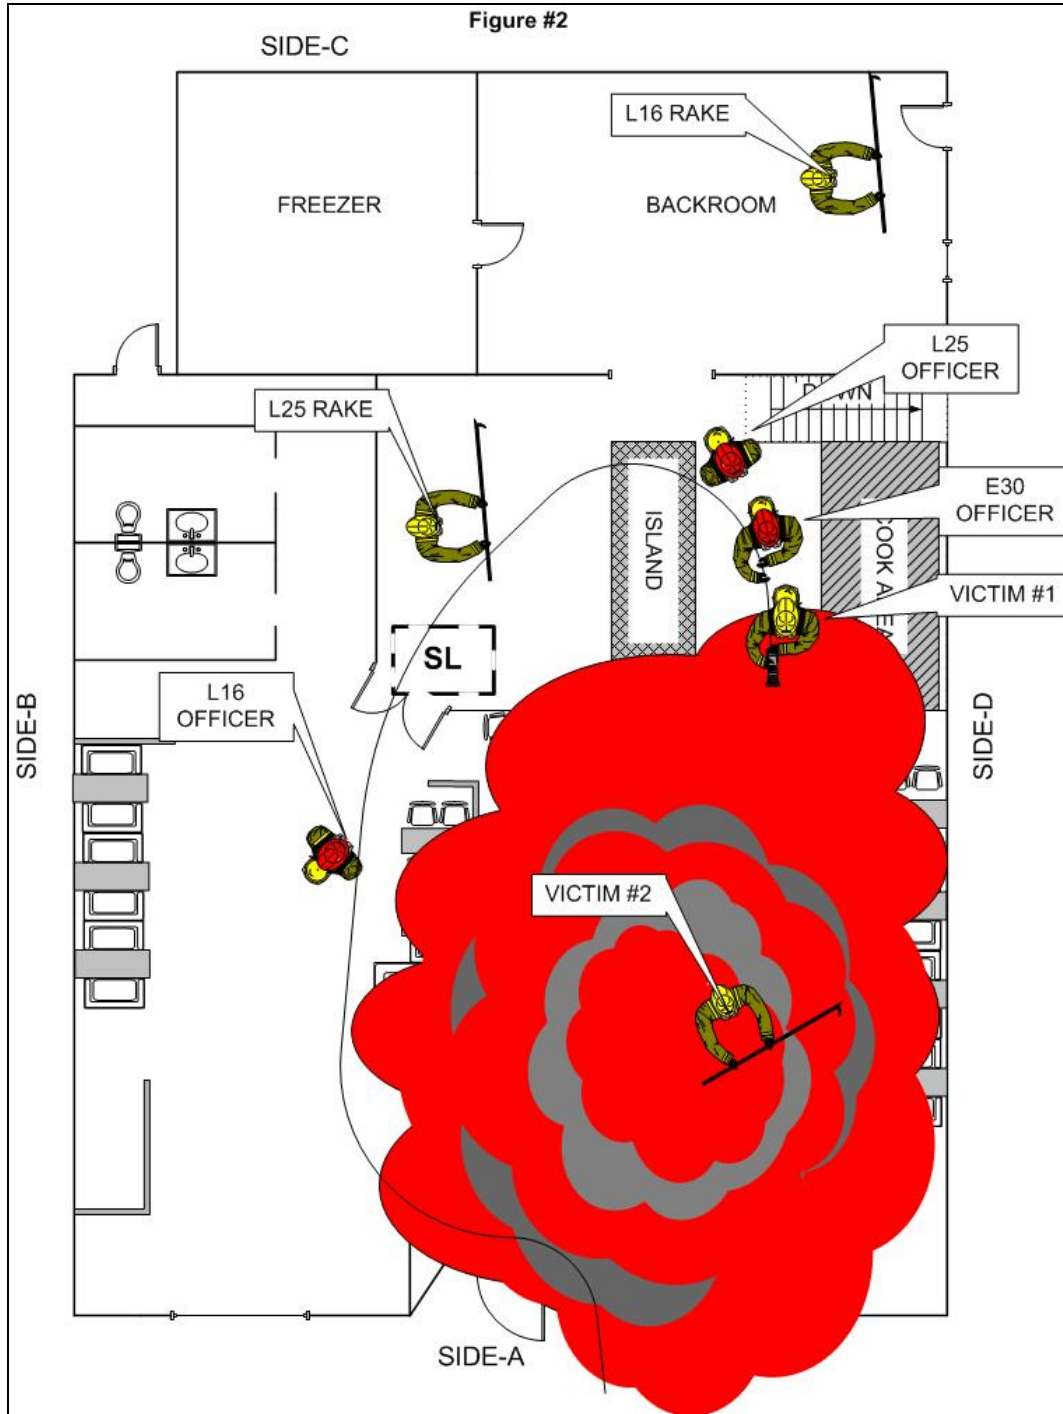
At approximately 2112 hours, the L25 officer told the L25 rakeman to stay with the handline as he went to look for an exit in the rear of the structure. The E30 officer and Victim #1 started to hear popping from the ceiling as it was coming down upon them. The smoke and heat conditions intensified forcing them to the floor. The L16 officer moved from the C-side of the dining room over to E30’s handline due to the deteriorating conditions. The smoke conditions were now banking to the floor and the heat forced the L16 officer to his knees. At approximately 2113 hours, as he awaited for the additional handline, he heard a loud crack and within a minute heard a loud rush. He described it as sounding like a “freight train” as a rapid fire event took place blowing down the ceiling tiles and a fireball blew out of the front of the structure (Photo 5, Photo 6). He described that the dining room turned orange. He felt hot water falling on him from the E30 handline in the kitchen (Figure 2).

Figure 2. Position of members at the ignition of the rapid fire event.

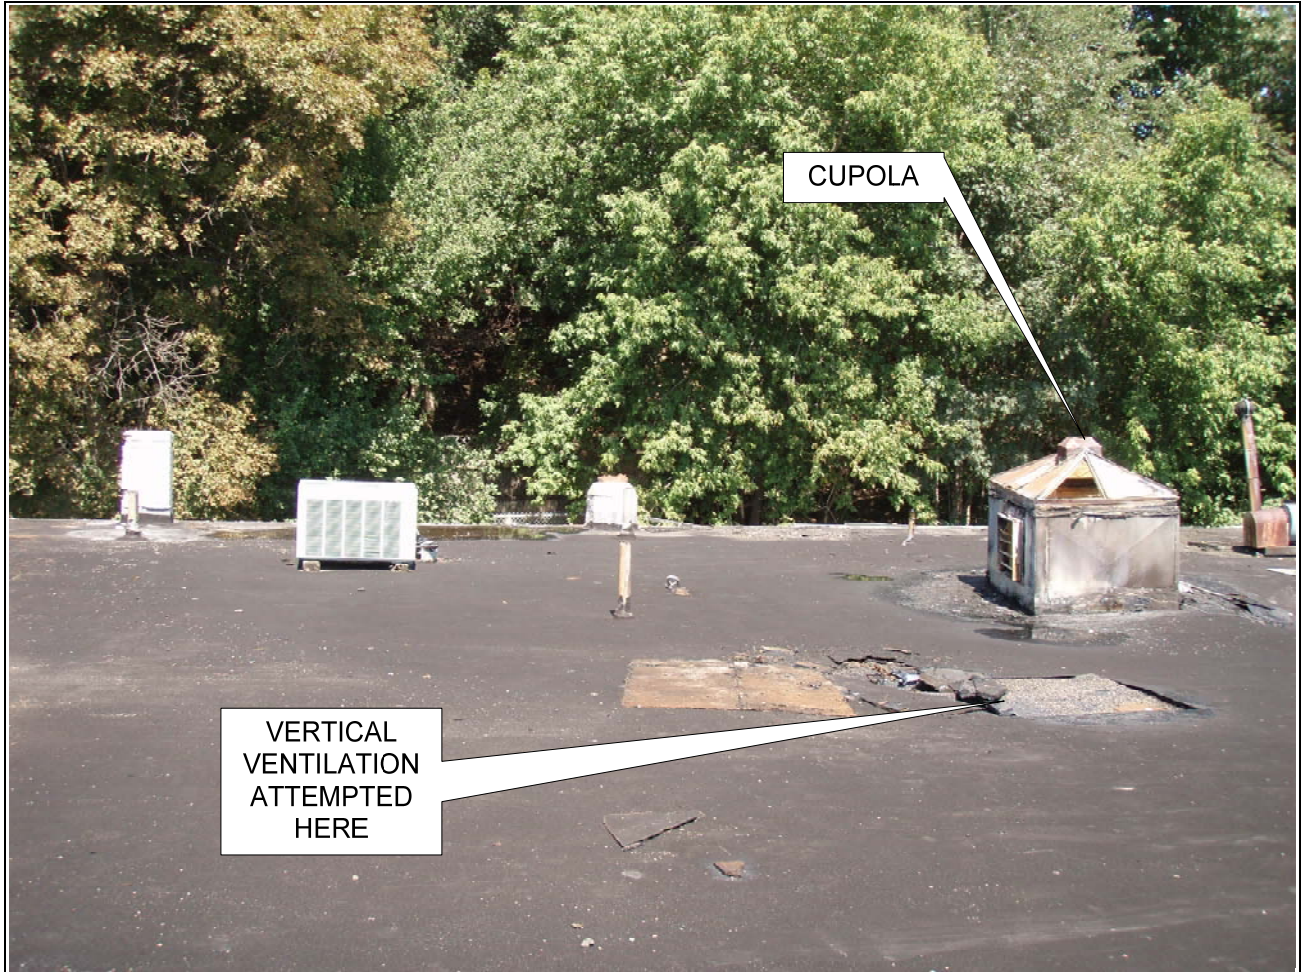
Photo 1. View towards C-side of structure from roof.
(Photo courtesy of fire department.)

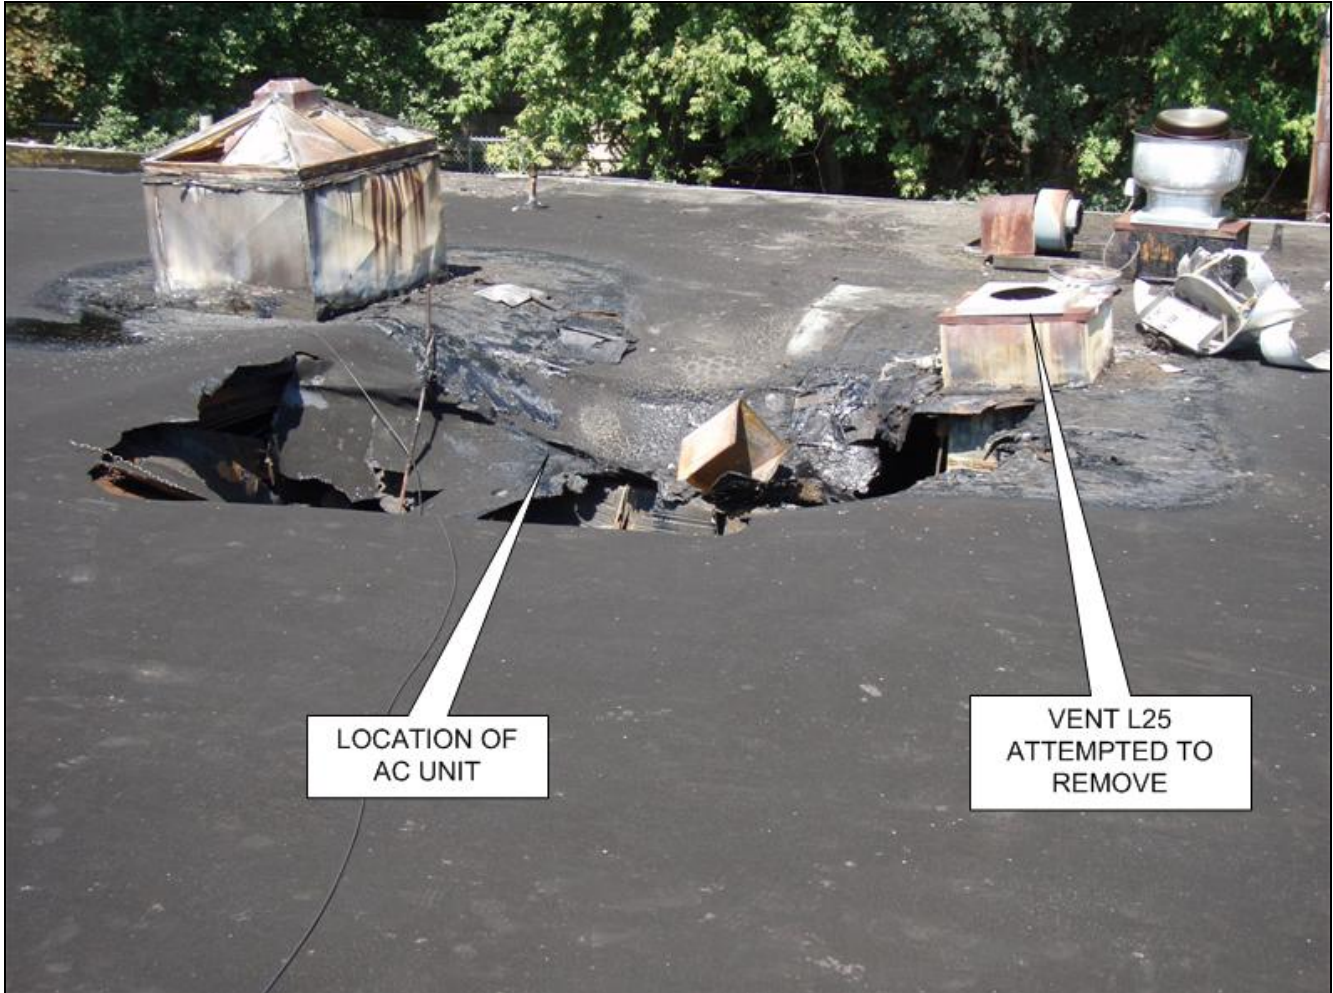
Photo 2. View towards D-Side of structure from roof.
(Photo courtesy of fire department.)

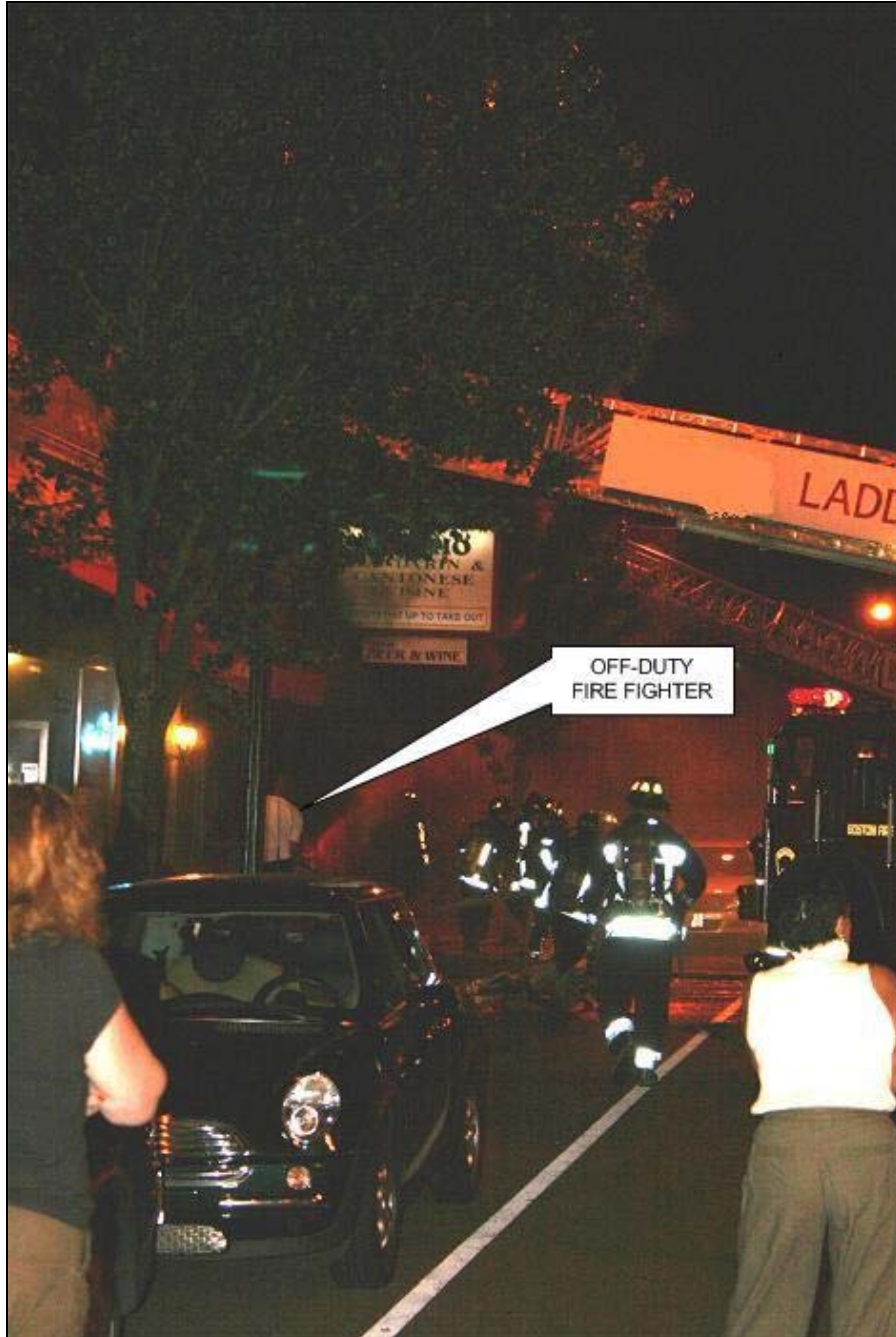
In this incident, vertical ventilation was never completed. The initial attack team and the initial IC were inside the structure fighting fire in the cockloft area that was open in the kitchen. The fire conditions worsened in the dining room area as thick black smoke began to bank down to the floor. Horizontal ventilation was performed on the front windows, which flanked the point of egress for the crews working inside. This provided oxygen to the fire and lead to a rapid fire event.

**Photo 3. Off-duty fire fighter in white T-shirt conducting initial vent at 2112:56 hours.
(Photo courtesy of fire department.)**

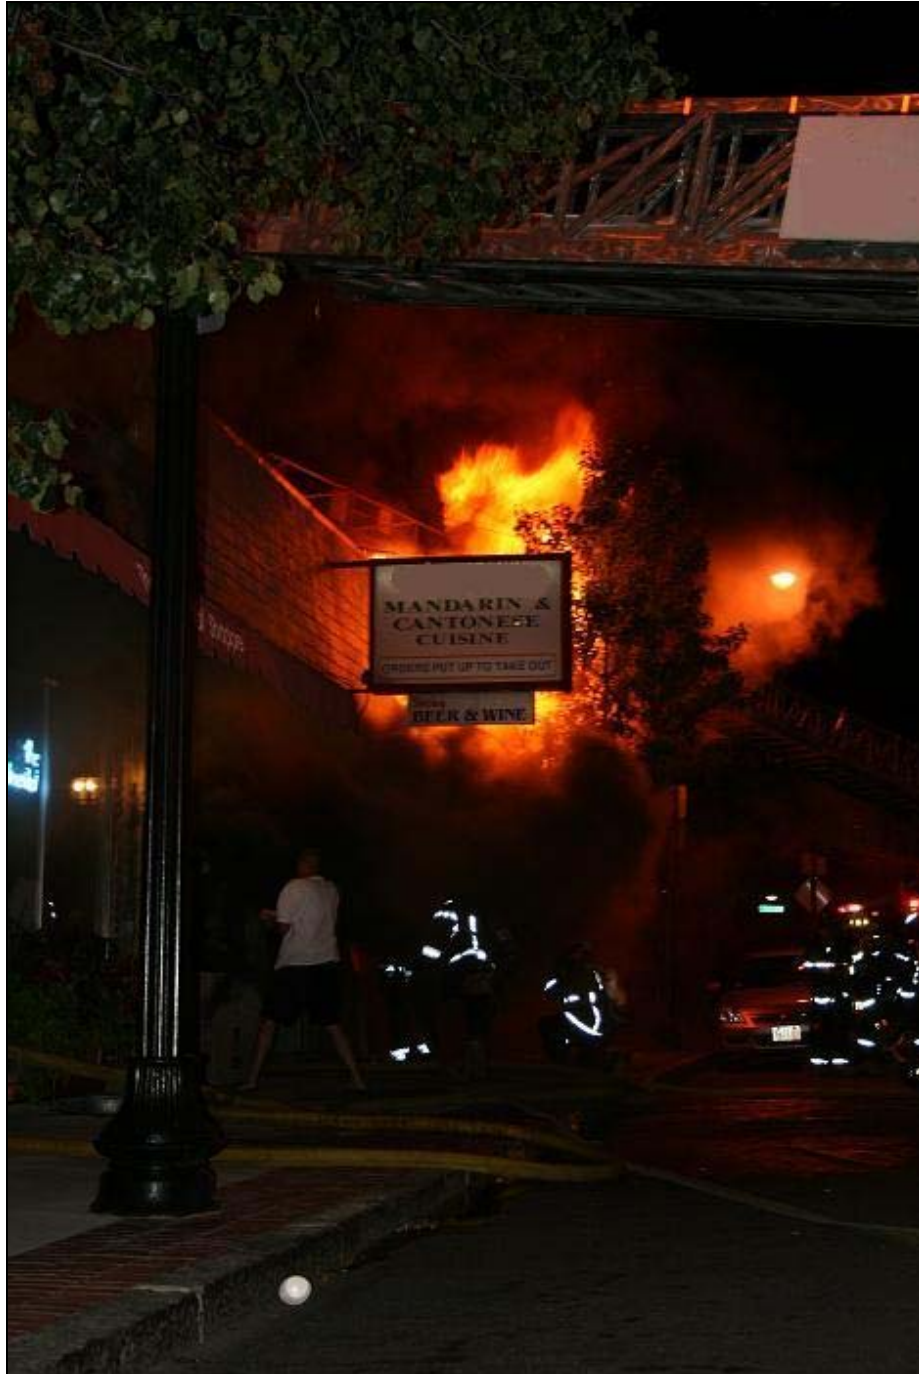
Photo 4. Conditions after venting at 2113:14 hours.
(Photo courtesy of fire department.)

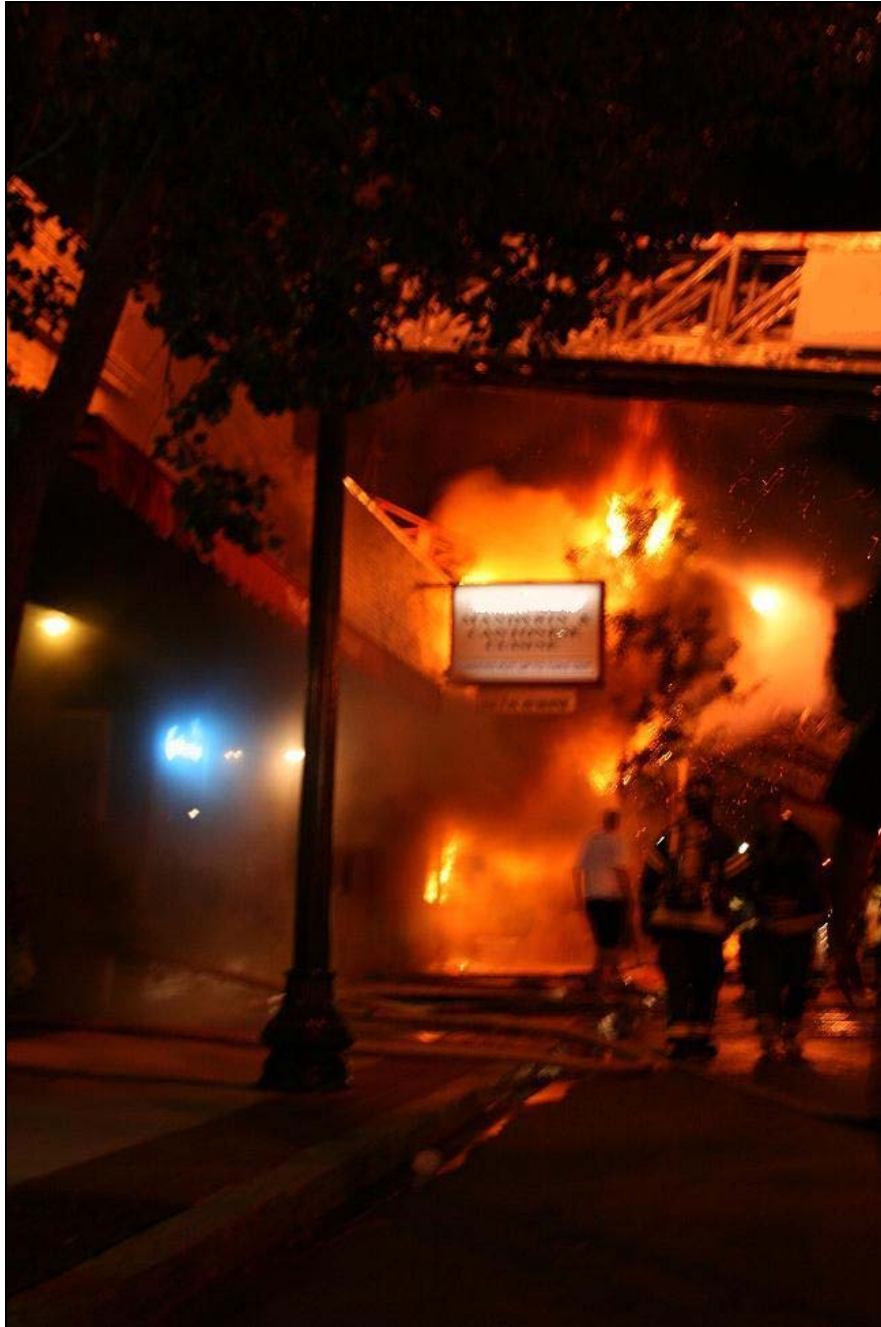
Photo 5. Conditions after venting at 2113:36 hours.
(Photo courtesy of fire department.)

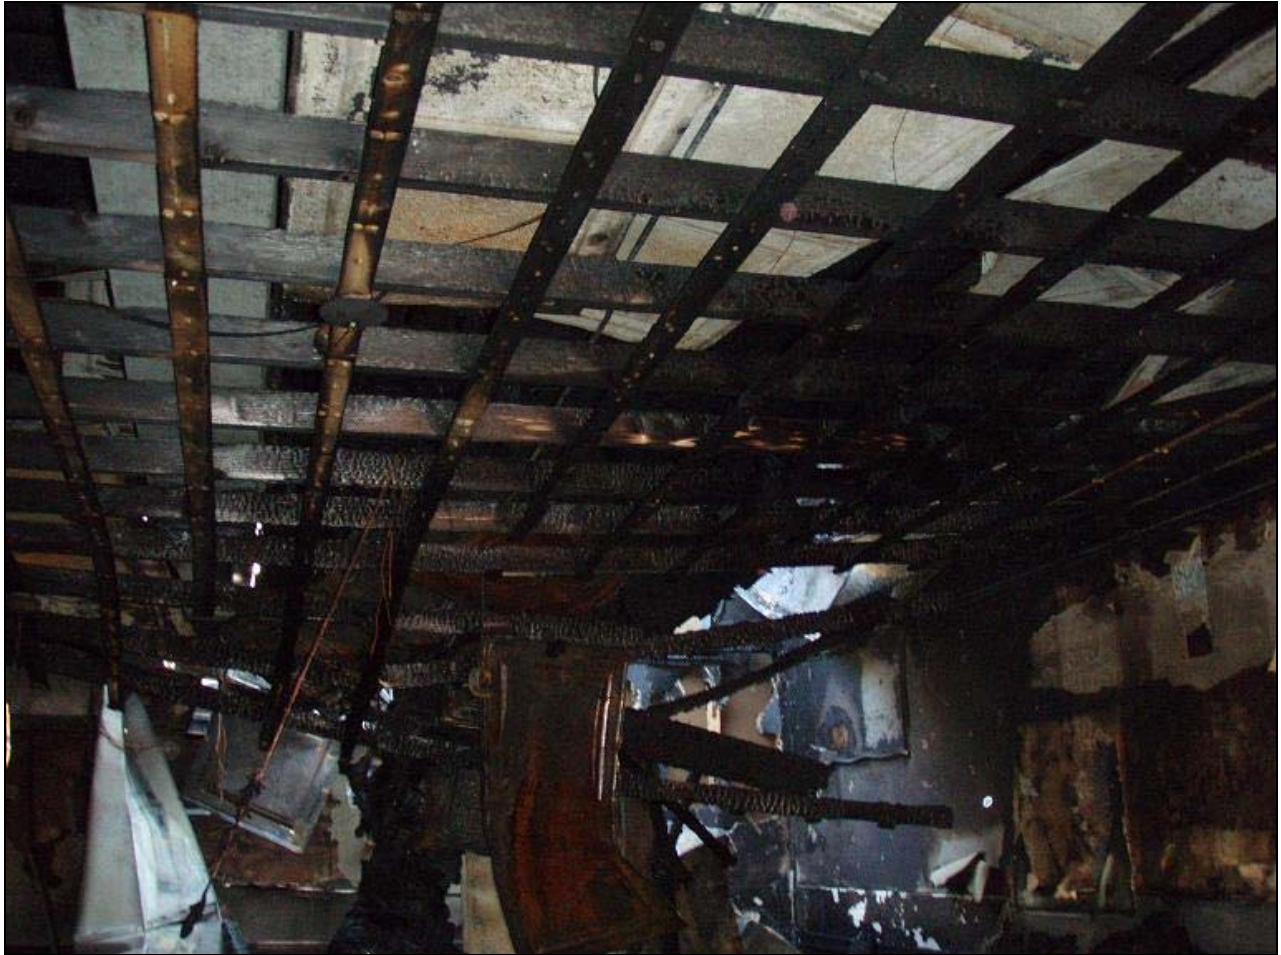
Photo 6. View looking towards kitchen and D-Side wall from dining room at exposed furring strips where the ceiling tiles were attached prior to the rapid fire event.
(Photo courtesy of fire department.)

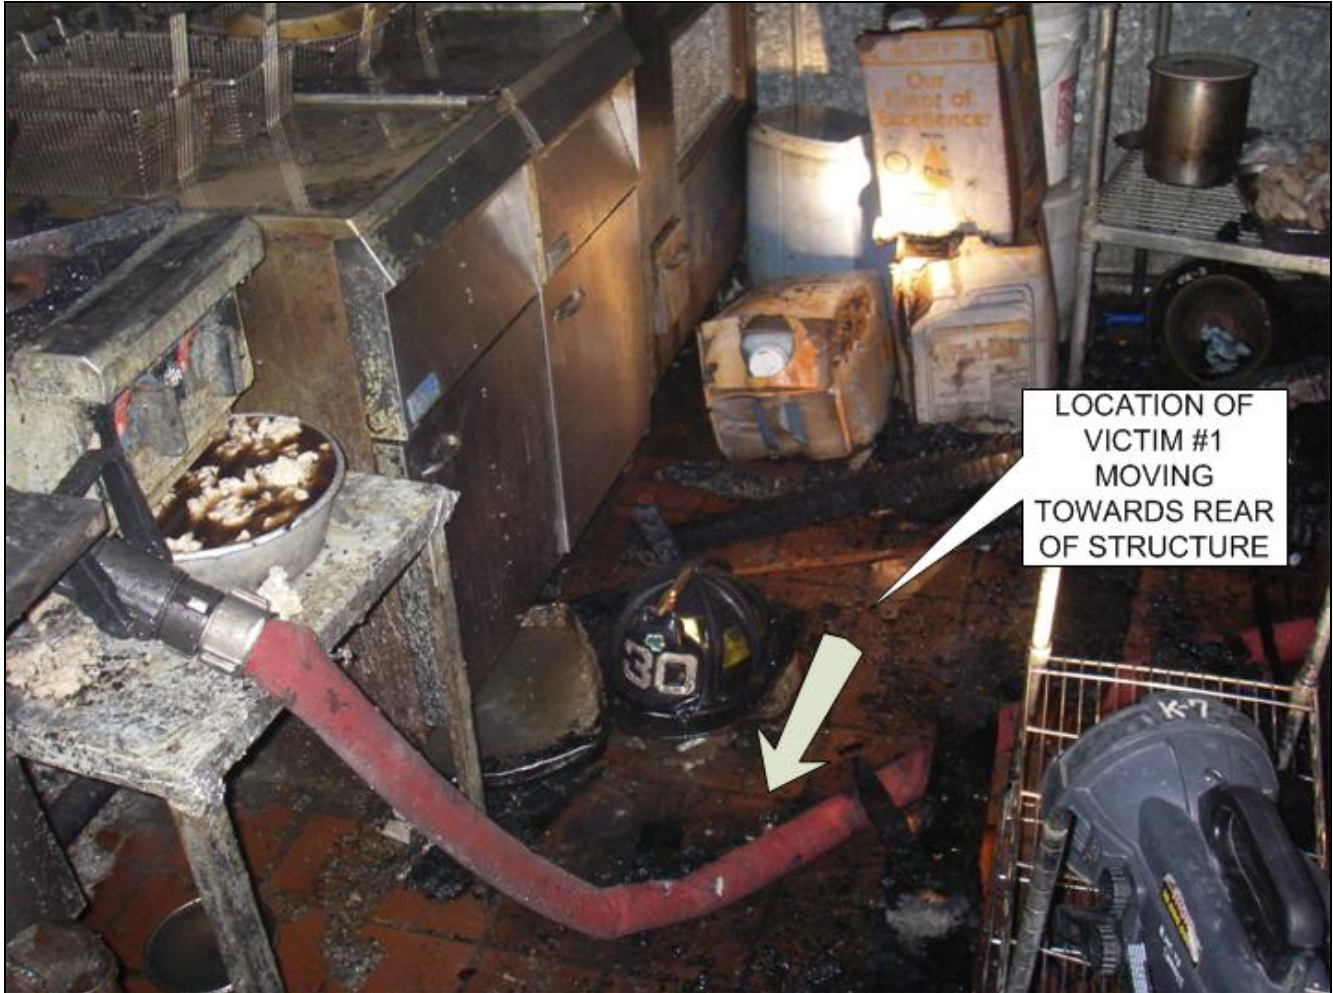
Photo 7. Location of Victim #1 in kitchen.
(Photo courtesy of fire department.)

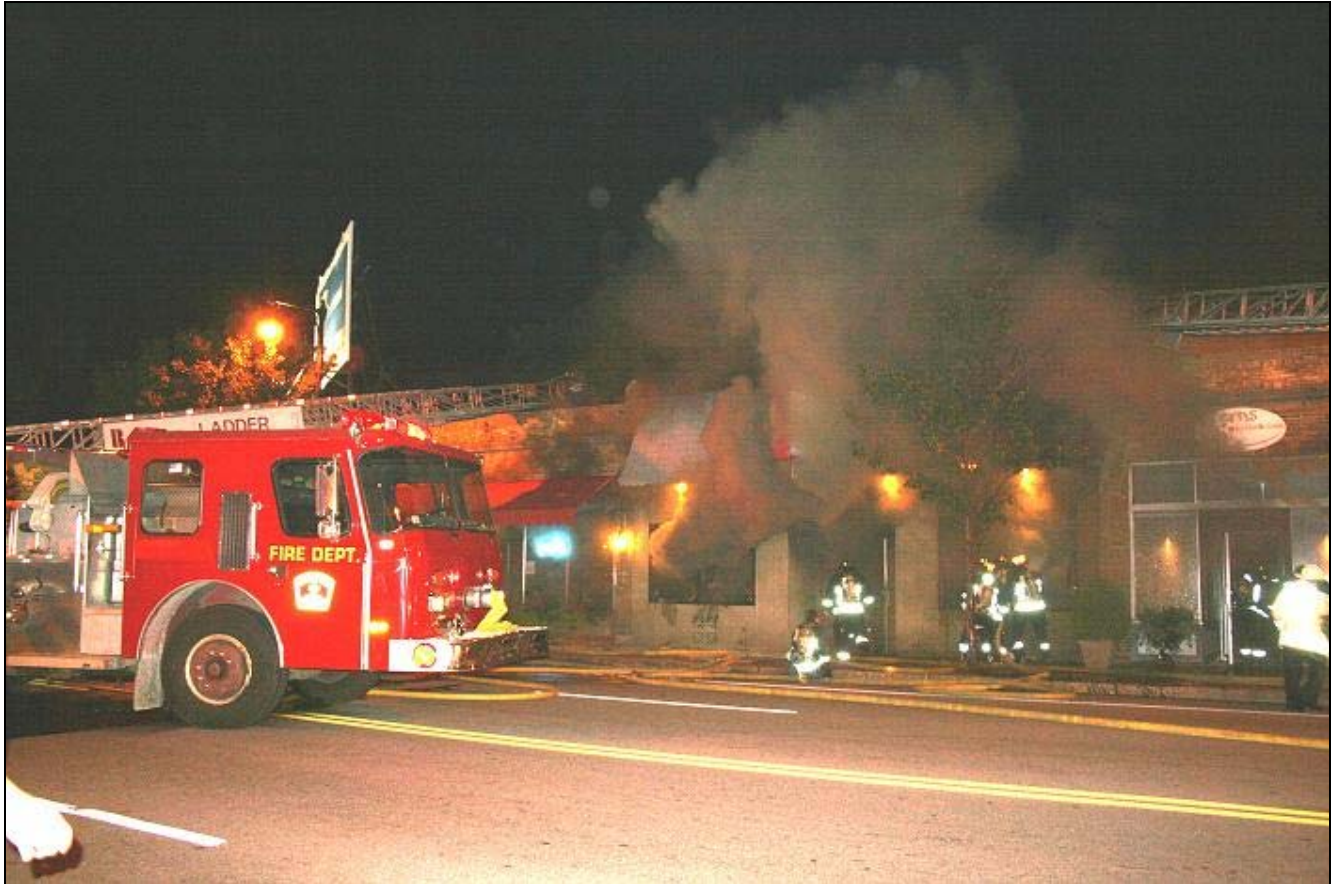
Photo 8. Conditions after venting at 2114:40 hours.
(Photo courtesy of fire department.)

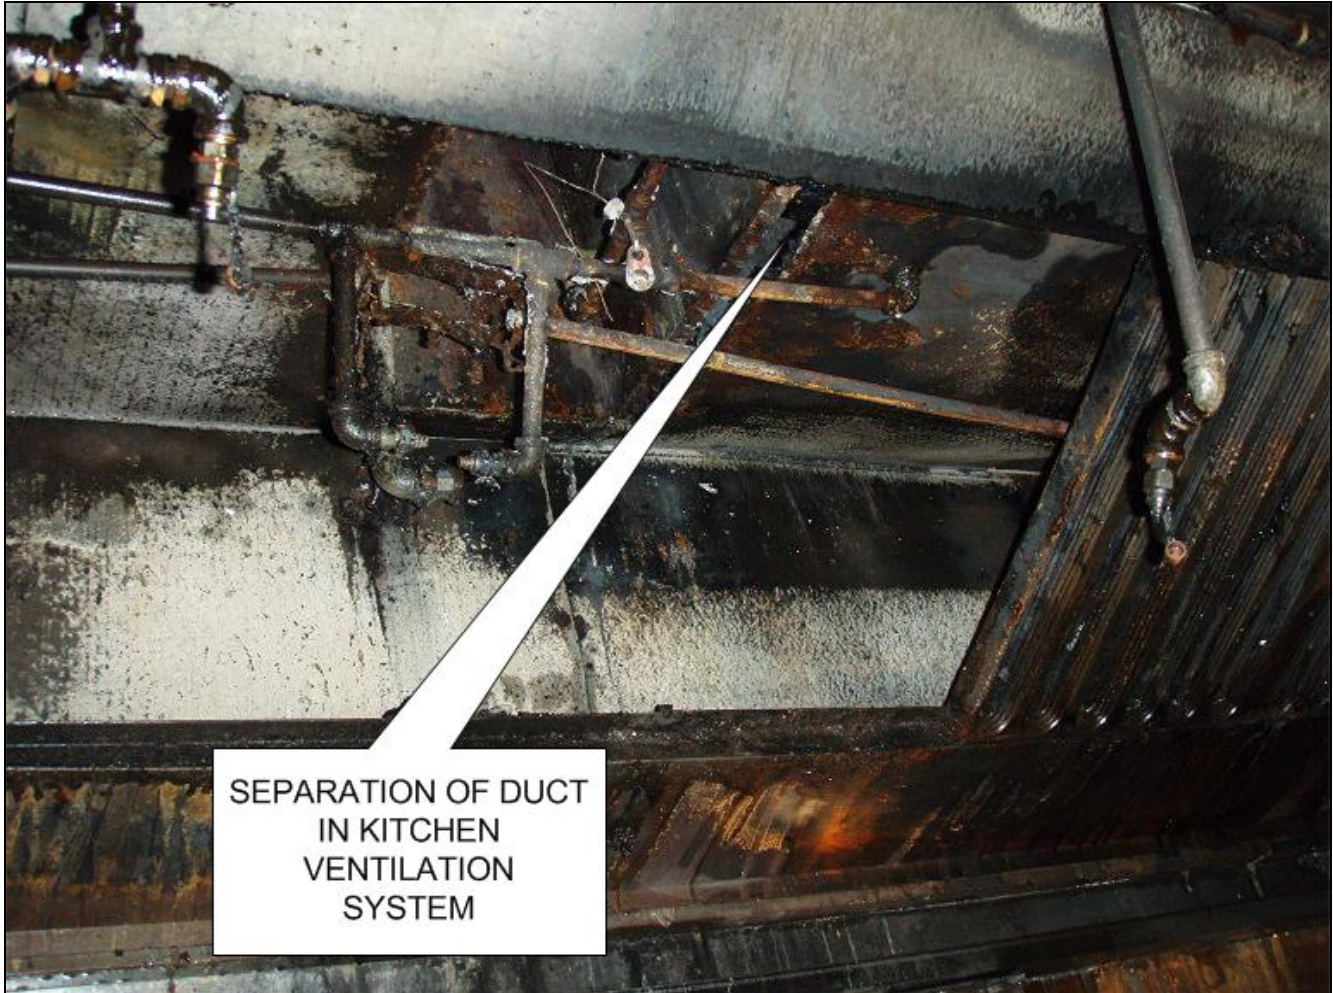
Discussion: The NFPA *Fire Protection Handbook* states “throughout history there have been building regulations for preventing fire and restricting its spread. Over the years these regulations have evolved into the codes and standards developed by committees concerned with fire protection. The requirements contained in building codes are generally based upon the known properties of materials, the hazards presented by various occupancies, and the lessons learned from previous experiences, such as fire and natural disasters.”³⁵ The restaurant where the incident occurred was constructed and in operation prior to the city adopting the requirements of NFPA 96, *Standard for Ventilation Control and Fire Protection of Commercial Cooking Operations*³⁶ into their building codes. After the fire, it was determined that there were multiple violations regarding the installation, materials, and maintenance used in the kitchen exhaust system. Some of the materials and installation discrepancies include: improper ductwork materials, improper/inadequate ductwork connections, penetration in ductwork, inadequate clearance to combustibles, lack of access for cleaning and inspecting, and the absence of ductwork enclosures. Ductwork should be 16 or 18-gauge stainless steel to withstand the intensity of a fire and provide for corrosive protection.^{36, 37} The seams should be liquid tight and the duct work should have the proper clearance to combustibles or be enclosed. It should also have access points for adequate cleaning and inspecting. The ductwork in this incident was galvanized sheet metal typically used for residential heating/cooling applications. The ductwork was connected with sheet metal screws and dovetail joints associated with that type of application. It had corroded and provided a large opening for the grease from the cooking operations to exit into the cockloft area (Photo 9).

Photo 9. View behind filter of kitchen ventilation hood.
(Photo courtesy of fire department.)

Recommendation #19: Code setting organizations and municipalities should require all commercial cooking operations to have periodic inspections of their kitchen exhaust systems and require all kitchen exhaust system installers to be certified to nationally recognized standards.

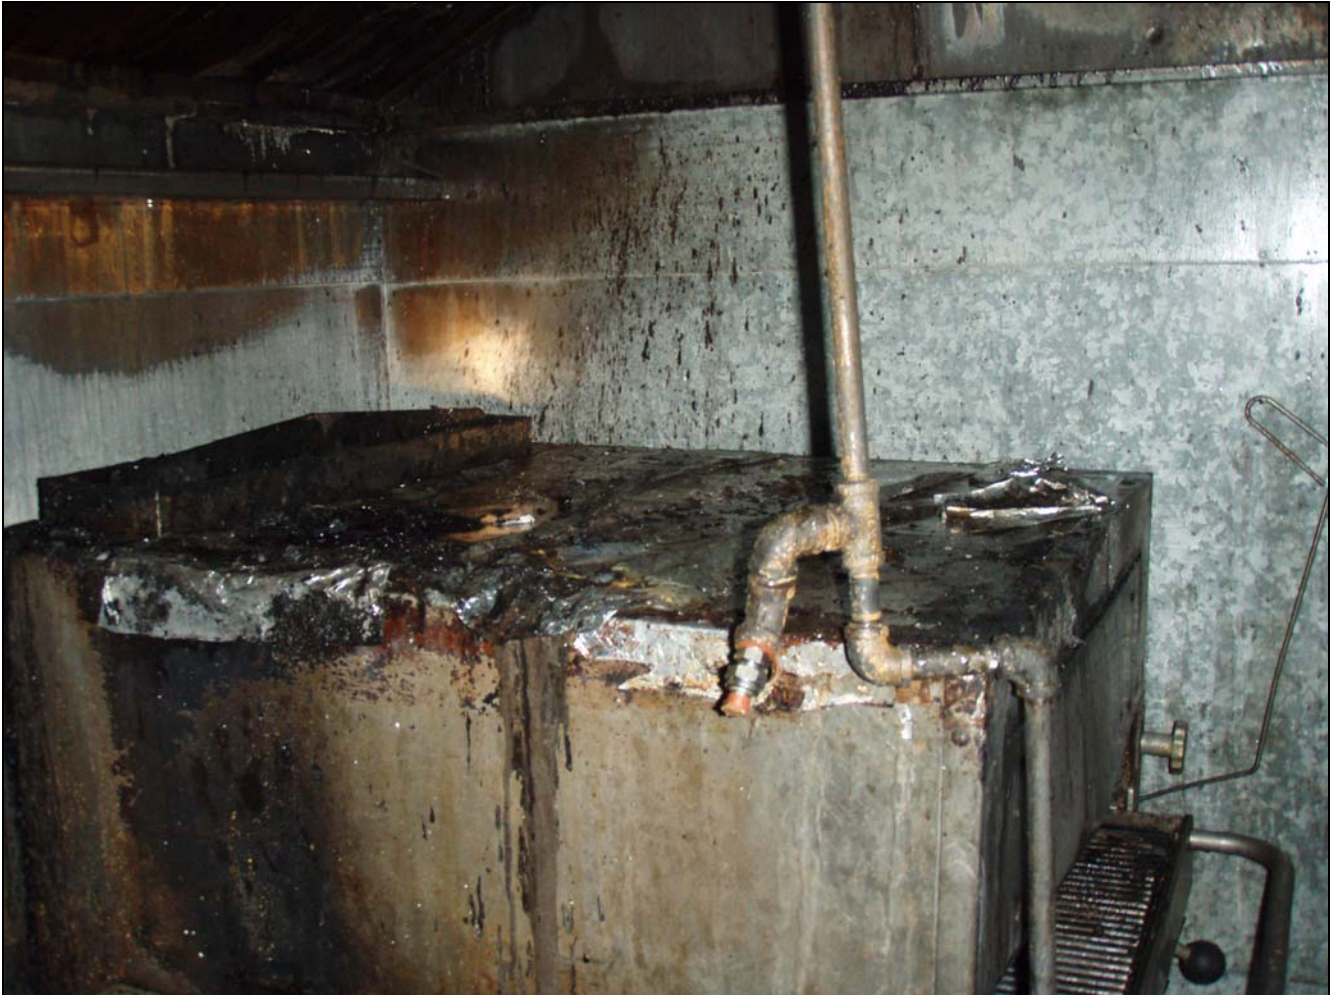
Photo 10. Foil placed on top of broiler to catch grease that dripped from ceiling.
Photo courtesy of fire department.
